Waterbody Data Sheet

Description			
Project Name: Line 5 Relocation Project		Date: 2019-09-06	Waterbody Survey ID: sasa004p
State: WI	County/Parish: Ashland	USGS Waterbody Name: UNT to Gehrman Creek	
Company: Enbridge	Crew Member Initials: NTT/DGL	Latitude: 46.365579	Longitude: -90.588129
Survey Type: <input checked="" type="checkbox"/> Centerline <input type="checkbox"/> Re-Route <input type="checkbox"/> Access Road <input type="checkbox"/> Facility <input type="checkbox"/> Other <small>(check one)</small>			
Waterbody Type: <input type="checkbox"/> River <input checked="" type="checkbox"/> Stream <input type="checkbox"/> Ditch <input type="checkbox"/> Swale <input type="checkbox"/> Canal <input type="checkbox"/> Other <small>(check one)</small>			
Water Appearance: <input type="checkbox"/> No Water <input checked="" type="checkbox"/> Clear <input type="checkbox"/> Turbid <input type="checkbox"/> Sheen on Surface <input type="checkbox"/> Surface Scum <input type="checkbox"/> Algal Mats <input type="checkbox"/> Other <small>(check one)</small>

APPENDIX F

Waterbody Data Sheets

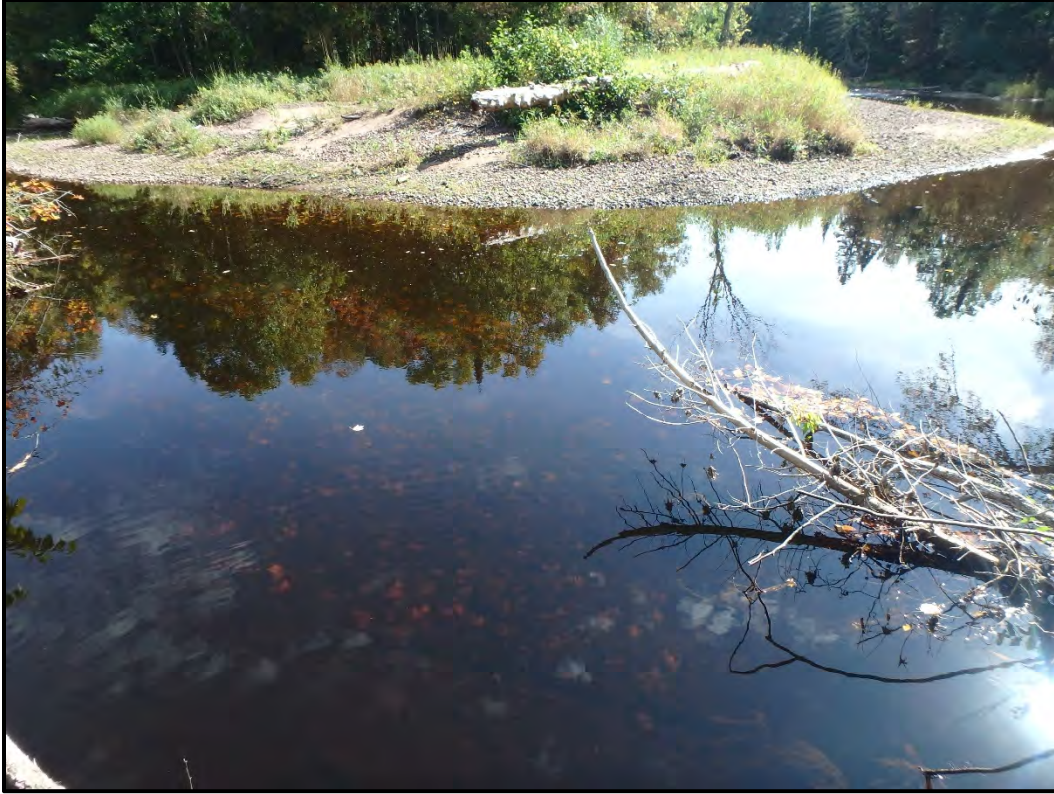
sira002p_E (across)

Observations			
Riparian Zone Present: <input type="checkbox"/> Yes <input checked="" type="checkbox"/> No <i>(check one)</i>			
Vegetation Layers: <input checked="" type="checkbox"/> Trees <input checked="" type="checkbox"/> Saplings/Shrubs <input type="checkbox"/> Herbs <i>(check all that apply)</i>			
Dominant Bank Vegetation (list): Acer saccharum, Abies balsamea, Ulmus americana.			
Aquatic Habitats (ex: submerged or emerged aquatic vegetation, overhanging banks/roots, leaf packs, large submerged wood, riffles, deep pools, etc.): Runs, riffles, pools, gravel bars, and woody debris providing habitat for aquatic invertebrates, amphibians, and fish.			
Aquatic Organisms Observed (list): None.			
Disturbances (ex: livestock access, manure in waterbody, waste discharge pipes): Heavily eroded banks. ATV trail along river edge.			
Observation Notes: None.
